**LPC# 031 186 0037 - Cook County
Marvel Engineering - Melrose Park
ILD 984 837 104
SF/HRS**

Site Reassessment

Title: CERCLA Site Inspection for Marvel Engineering

**MARVEL ENGINEERING
ILD 984 837 104
LPC 031 186 0037
MELROSE PARK, ILLINOIS**

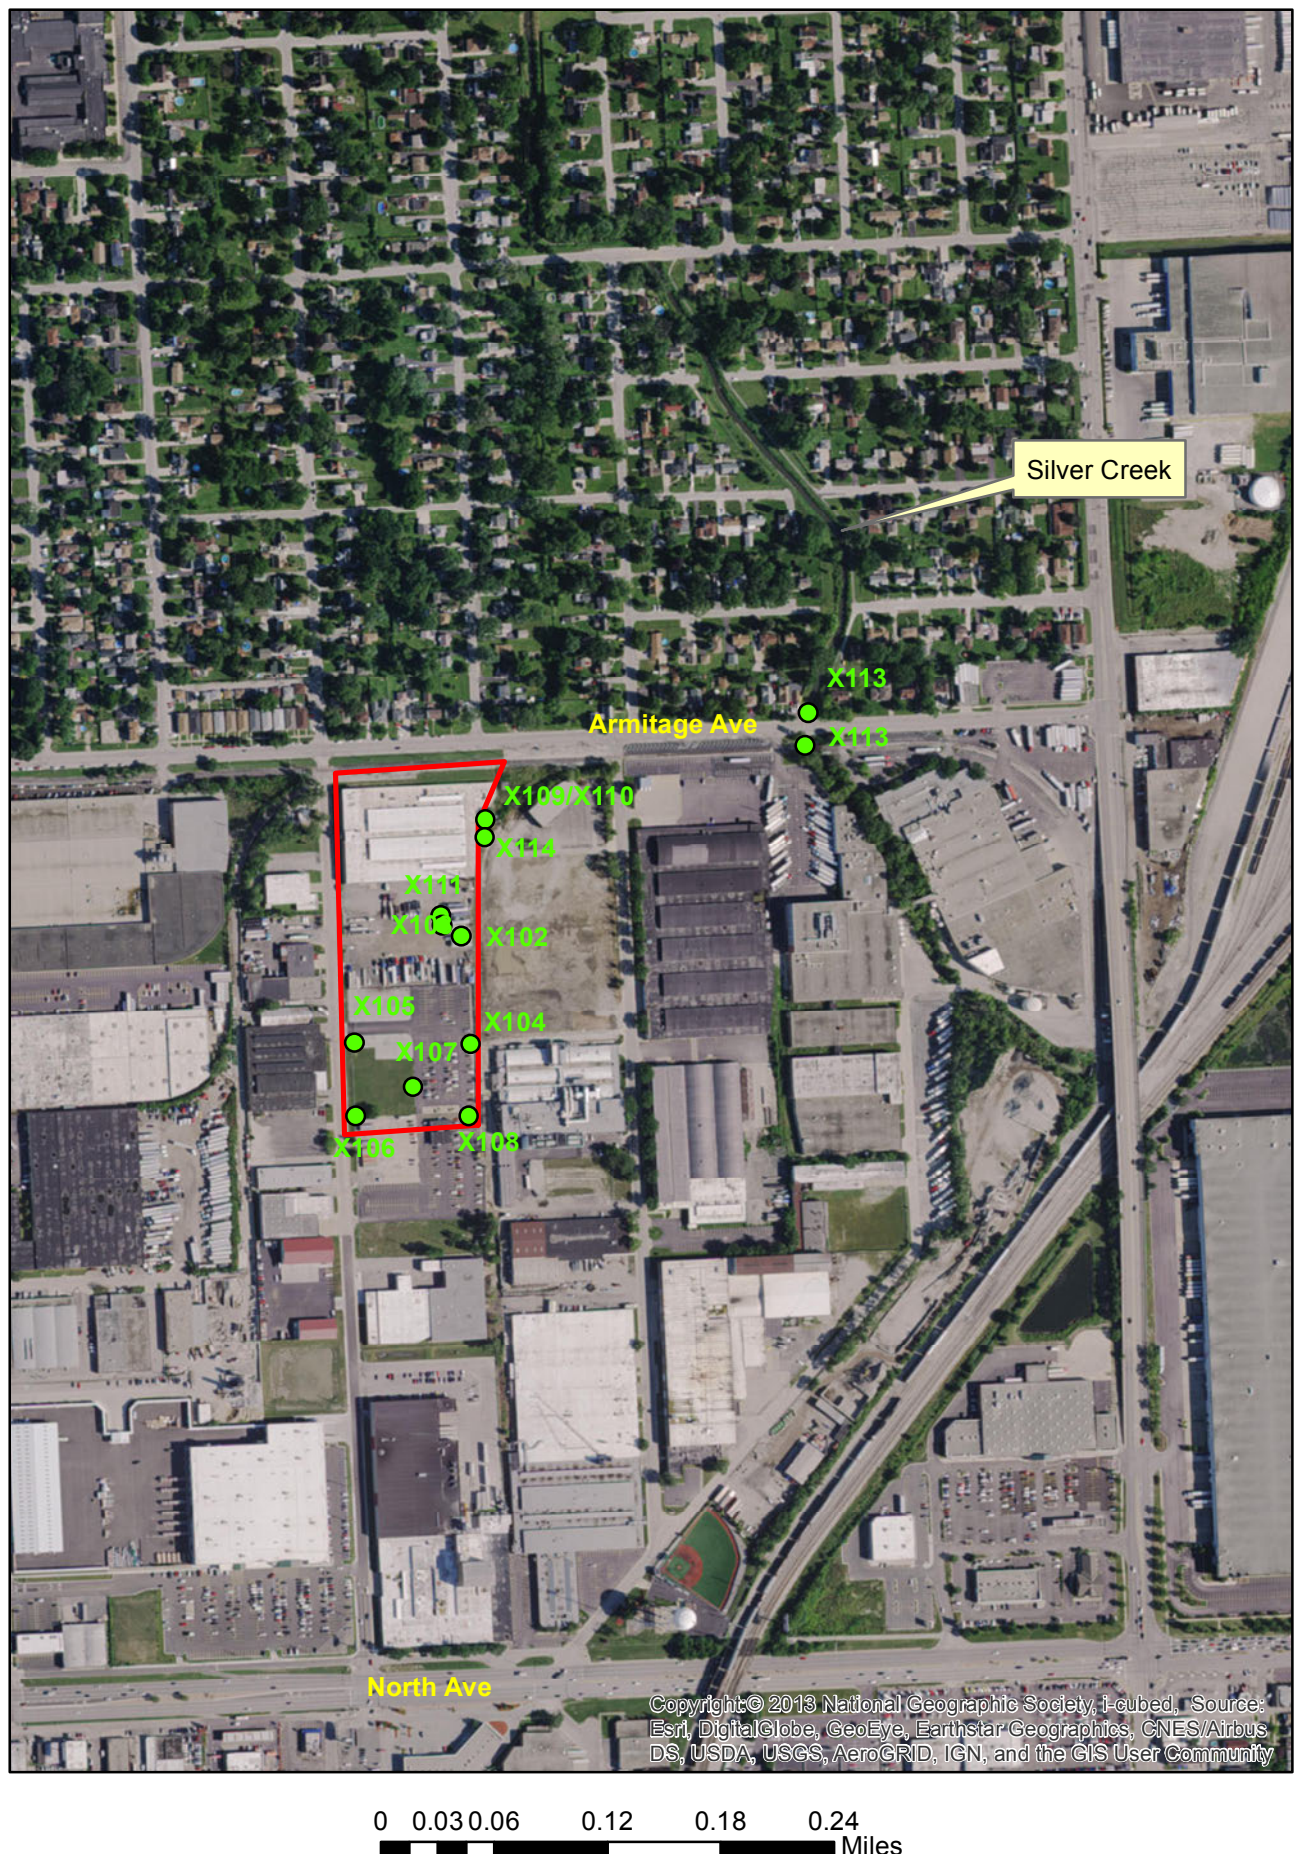
Figure 5 - IS Sample Location Map

Superfund chemical Data Matrix (SCDM) values were exceeded for benzo(a)anthracene, benzo(a)pyrene, benzo(k)fluoranthene, dibenzo(a,h)anthracene, and indeno(1,2,3-cd)pyrene (Table 4). One sample X114 (1.4 ppm) exceeded the polychlorinated biphenyl SCDM value (1 ppm). The highest level of Aroclor 1254 was found just downgradient from a former fenced area containing transformers.
